Preprint. of The Annual Meeting of The Intern.
Congress on Glass

Sept 1966 Tokyo

RADIATION DAMAGE OF GLASS BY ULTRA-VIOLET RAY

Kazuo Ooka, Toru Kishii
Tokyo Shibaura Electric Co., Ltd., JAPAN

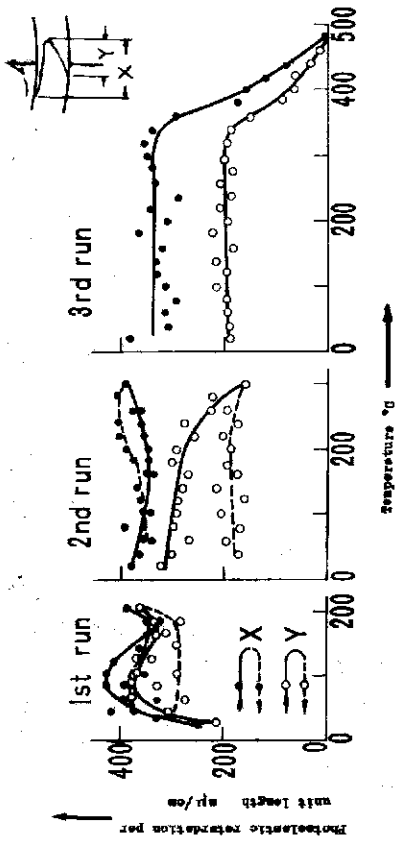
In a fractured bulb made of 96 % silica glass, the stressed layer was thicker than in the case of the Tefex glass, as illustrated in Photograph 3, probably due to its better ultra-violet transmission. By heating, the stresses induced in these glasses were released at rather lower temperatures than the annealing points as shown in Figures 1 and 2.

Figure 1 Stress release at the inner surface of a Terex glass bulb
(Annealing point of the glass: about 545°C)

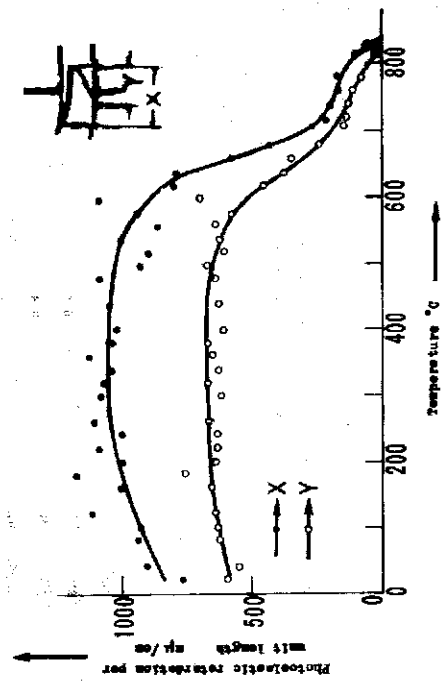
Fig. 2 Stress release at the inner surface of a
96% silica glass bulb
(Annealing point of the glass: about 900°C)

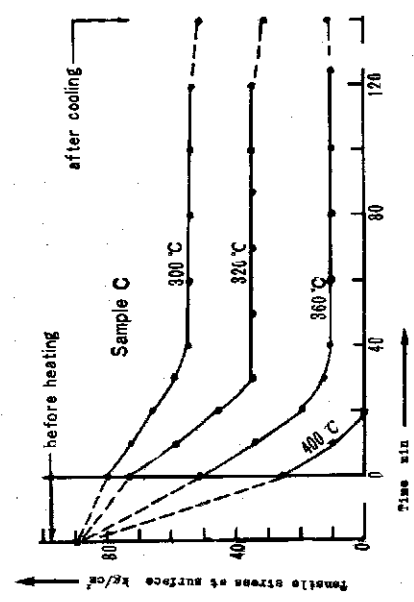
Thermal release of the stress at various temperatures investigated for fragments of the fractured Terex glass bulb are shown in Figure 3. The stress release was found to occur even at the temperature as low as 250° C, and the stress disappeared completely in a short time at 400° C, which is far below the annealing point of the glass (about 545° C) i. e. the temperature at which the ordinary stress in the glass is released by the viscous flow.

Fig. 3 Stress in a Terex glass bulb at various temperatures

The efficient methods to prevent the fracture of bulbs of mercury lamps are, to use the borosilicate glasses containing some amount of PbO or ZnO , to lessen the amounts of ions in glass which absorb ultra-violet ray and to heat the bulbs at 400°C certain intervals.

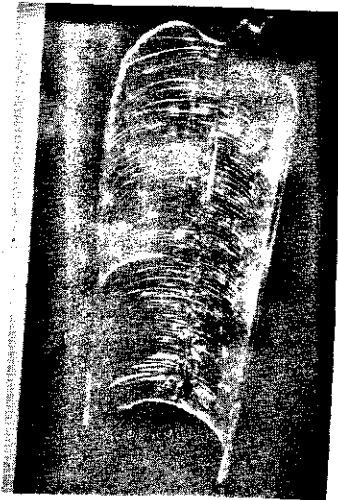
In the course of development of high power mercury discharge lamps in the factory, stress built-up has been observed in protection bulbs of the lamps after long periods of lighting. In some cases, fracture of bulbs took place spontaneously.

The fractured bulb, whose inner surface was subjected to severe ultra-violet irradiation for a long time, is illustrated in Photograph 1. Many fine cracks are seen at the inner surface. Photoelastic observation of a cross section of a fragment of the bulb (Telex glass; SiO₂ 80, B₂O₃ 13, Na₂O 4, K₂O 1 and

Photograph 1 Outer protection bulb of a high pressure mercury discharge lamp damaged by ultra-violet irradiation

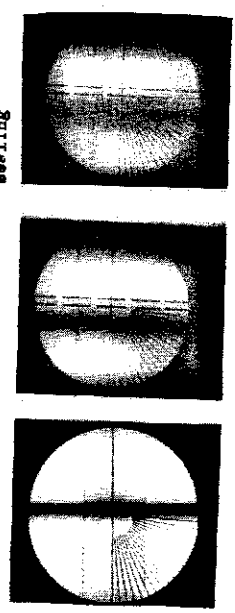
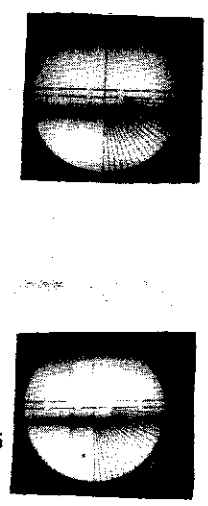
Various kinds of commercial glasses were irradiated by a 400 W silica glass mercury lamp for 1,000 hr. Specifications of the glasses are given in Table 1. Stresses at the irradiated surfaces and thicknesses of the stressed layers are shown in Table 2. Some of the photoelastic patterns of the stressed layers are illustrated in Photograph 4.

The stress build-up was observed only in some kinds of borosilicate glasses. In the borosilicate glasses containing PbO (Glass 5) or ZnO, (Glass 8), the stress was weak or not detected. For the ultra-violet transmitting borosilicate glass (Glass 8), the stressed layer was considerably thick.

Photograph 4 Photoelastic observation of surfaces of various commercial glasses irradiated by ultra-violet ray

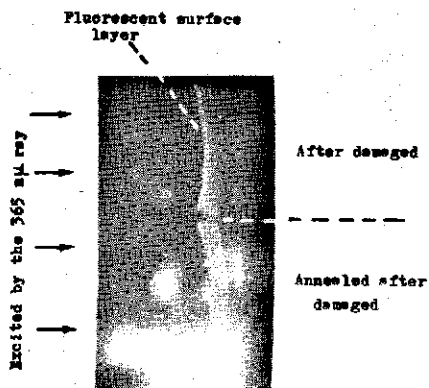
The stressed layer of the sample A showed fluorescence by excitation with the 365 m μ line (Photograph 5) and thermal glow by heating (Figure 5). The stressed layer of the sample B showed neither fluorescence nor thermal glow.

Photograph 5 Fluorescence of a strained surface layer of Terex glass bulb (sample A) by excitation with the 365 $m\mu$ ray (photographed through a green filter to cut of the exciting ray)

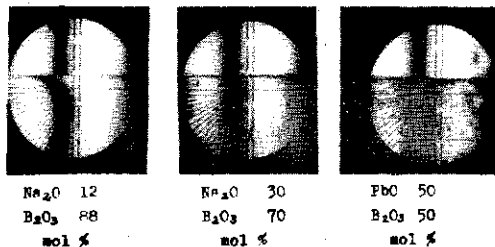
Effects of ultra-violet irradiation on binary borate glasses were investigated. Compositions of these glasses are given in Table 3. After irradiation for 1,000 hrs by a 400 W silica glass mercury lamp, stress build-up at the irradiated surfaces were examined. It was detected only for the binary glasses with alkali oxides. The results are summarized in Table 4. Some results of the photoelastic observations are illustrated in Photograph 7. In binary alkali-germanate glasses, the stress build-up was not observed even after irradiation for 1,000 hr.

Photograph 7 Photoelastic observation of the irradiated surfaces of binary borate glasses
