Preprint. of The Annual Meeting of The Intern.
Congress on Glass

Sept 1966 Tokyo

RADIATION DAMAGE OF GLASS BY ULTRA-VIOLET RAY

Kazuo Ooka, Toru Kishii
Tokyo Shibaura Electric Co., Ltd., JAPAN

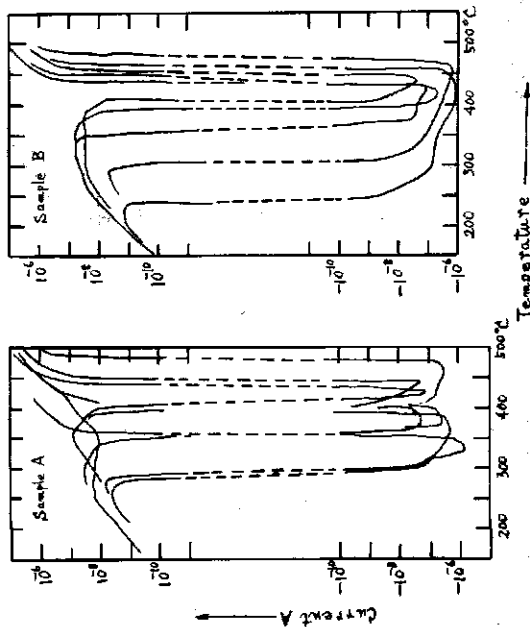
Fig. 5 Thermal glow curves for the Pyrex (sample A) and the Pyrex (sample B) glass bulbs

The stressed layer of the sample A showed fluorescence by excitation with the 365 m μ line (Photograph 5) and thermal glow by heating (Figure 5). The stressed layer of the sample B showed neither fluorescence nor thermal glow.
